# **EXHIBIT "A"**

Re: Jeffrey Glover & Tresa Glover v. Graphic Packaging International, LLC

Date of Accident: 01/11/2022

**Re: Subject :** Jeffrey Glover & Tresa Glover v. Graphic Packaging International, LLC  
**Date of Accident :** 01/11/2022  
**Civil Action No. :** 2:22-CV-00191  
**Our File No. :** 22264

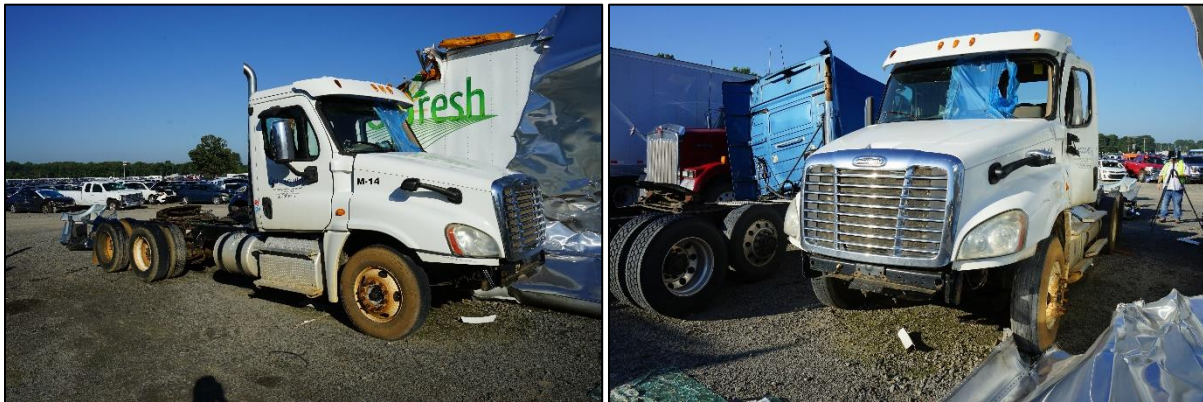
The Freightliner tractor was examined and documented by Aperture on August 26, 2022. The Freightliner tractor had been examined and documented by others prior to our inspection. Photographs and videos taken by others have been reviewed and relied upon. The Freightliner sustained damage to the driver side. Fiberglass fractures, scraping, and scratching were visible on portions of the hood and cab. The front bumper was missing. Scratch patterns were visible along the driver's side steps. The driver's side of the windshield was broken. The scratch patterns extended longitudinally rearward with a downward angle from top to bottom. The heavy vehicle event data recorder (HVEDR) was removed before the time of our inspection and had been downloaded by others. The Freightliner was also equipped with an AT&T Fleet Complete fleet monitoring system. Three tires were found to be in violation based on tread depth.

*Figure 1. Damaged Freightliner Cascadia*

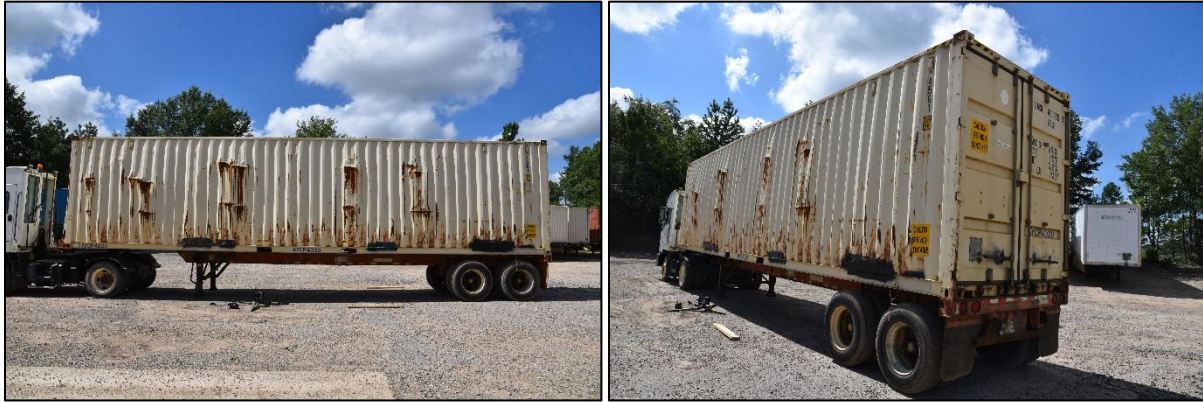
The trailer was examined and documented by Aperture on August 26, 2022. The trailer had been repainted prior to our inspection. The trailer had been examined and documented by others prior to our inspection. Photographs and videos taken by others have been reviewed and relied upon. The trailer sustained damage to the driver side of the container. Scratch patterns were visible along the driver side of the trailer. The scratch patterns extended longitudinally rearward with a downward angle from top to bottom. Indentations extending outward along the driver's side of the trailer were also visible.

*Figure 2. Damaged trailer photographs taken by others prior to re-paint.*

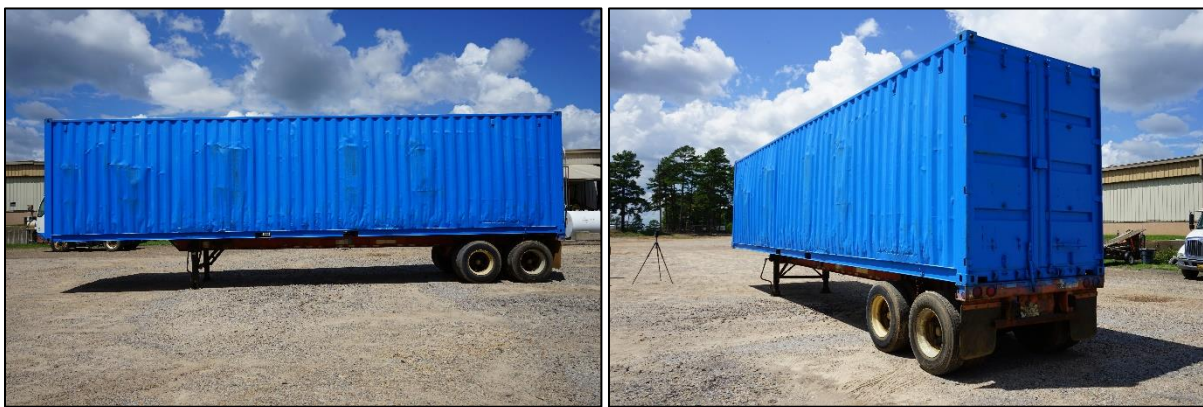
*Figure 3. Damaged trailer photographs taken by Aperture after re-paint.*

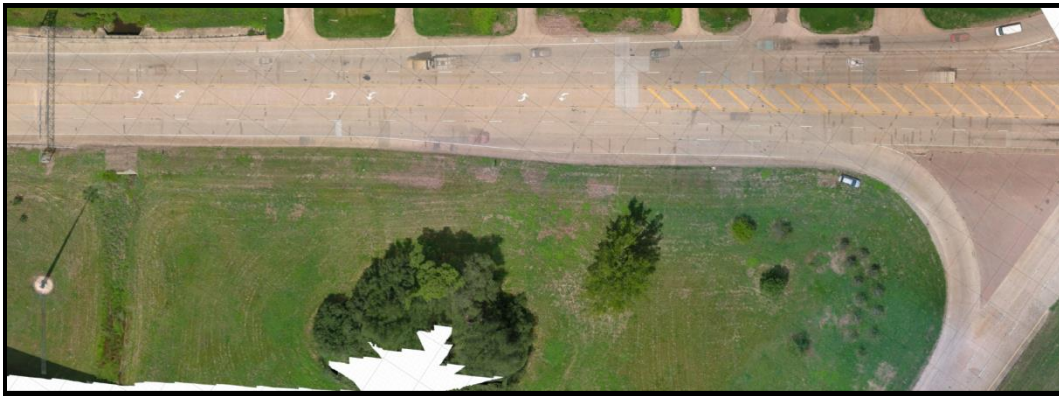
The accident scene was inspected and documented by Aperture on August 26, 2022. Physical evidence of the accident was present at the time of our inspection. Pavement scratching was still visible at the time of our inspection. The geometry of the roadway was documented at this time. US-59 was made up of three lanes. Two lanes were marked for straight-through traffic at the intersection. The right lane was marked for right turn travel onto Bishop Road. The right lane is slightly uphill and flattens when connecting with Bishop Road. The radius of the right turn was measured from inside to outside edge of roadway, approximately 97.1 to 129.3 feet.

Figure 4. Accident scene documented on August 26, 2022.

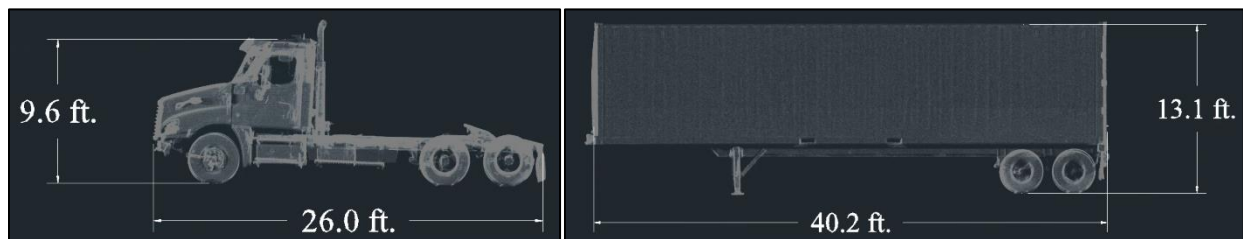
The physical evidence (documented vehicle damage) has been evaluated to determine the relative orientation at impact. Damage to the Freightliner began at the front of the vehicle and continued rearward to the back of the vehicle. The height of the damage extended up to approximately 9.6 feet. Damage to the trailer began at the front of the trailer and continued rearward to the back of the trailer. The height of the damage extended up to approximately 13.1 feet. The damage pattern indicated the Freightliner tractor and trailer rolled over onto its driver side and proceeded to slide across the roadway surface before coming to final rest.

Figure 5. Three-dimensional scan data of Freightliner tractor-trailer.

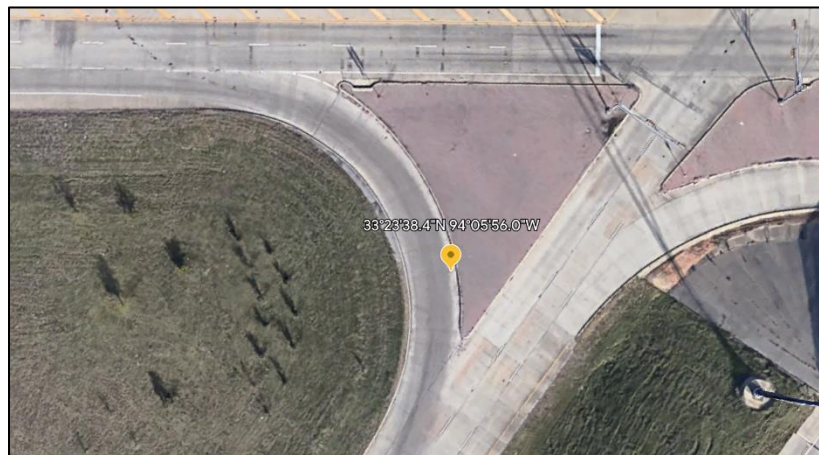
Data associated with AT&T Fleet Complete were provided in the form of an excel spreadsheet. This data is associated with GPS equipment installed in Mr. Glover's Freightliner at the time of the accident. The data provided indicated the Freightliner experienced a "harsh cornering" event at approximately 10:44am CST. The "harsh cornering" threshold value is not given in the provided data but is available to Abernathy. The lateral acceleration values required for "harsh cornering" were recorded via internal accelerometers installed in the AT&T Fleet Complete hardware. The event was triggered at (33.39399, -94.09888). The accuracy provided indicated a value of 6 meters (19.7 feet). The speed provided indicated the Freightliner was travelling approximately 22 mph through the right turn prior to the rollover event. The speed was recorded via direct ECM data or GPS data.<sup>5</sup>

*Figure 6. "Harsh Cornering" event provided by AT&T Fleet Complete.*

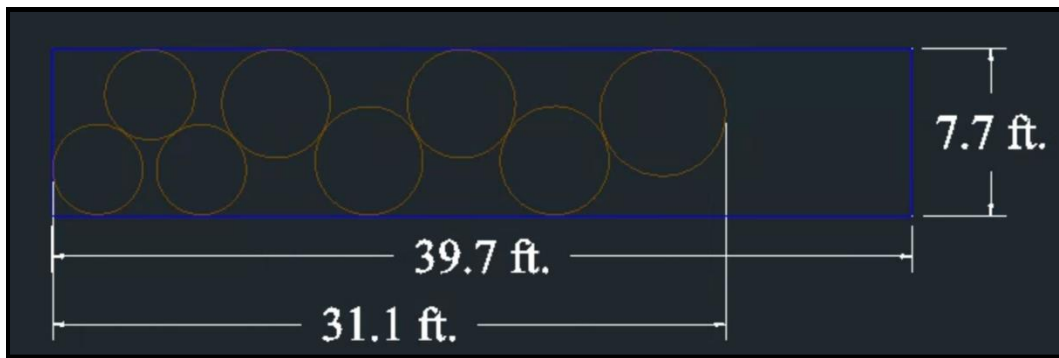
Statements by Ashly Myers and Cory McMurry with Abernathy indicated the trailer was improperly and unsafely loaded on the day of the accident due to the load pattern. Mrs. Myers stated the trailer was improperly and unsafely loaded by not loading the trailer far enough back. Mrs. Myers stated the load did not even reach the 30-foot mark of the trailer. Mr. McMurry stated that almost the entire back one-third (13 feet) of the trailer had no cargo in it. Mr. McMurry stated any 40-foot trailer carrying that amount of weight should be loaded to at least the 30-foot line in the trailer. A load pattern analysis was performed utilizing published interior dimensions of the 40-foot cargo container and compared to real-world observations taken during the vehicle inspection. The interior length of the cargo container is approximately 39.7 feet. The interior width of the cargo container is approximately 7.7 feet. Positioning the load as far forward as possible, the end of the 70-inch roll is at minimum approximately 31.1 feet from the front of the trailer. This is inconsistent with the statements by Mrs. Myers and Mr. McMurry.

*Figure 7. Load pattern utilized in Mr. Glover's trailer on the day of the accident.*

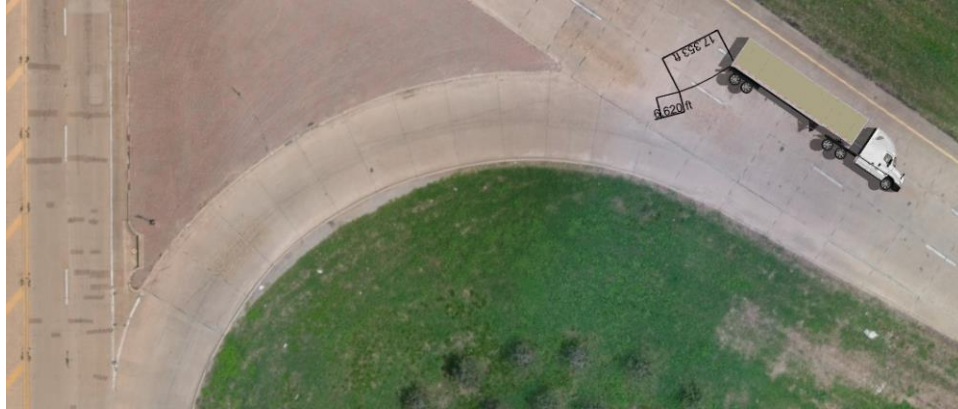
Video taken at the scene depicts the final rest position of the tractor-trailer. Also, visible were impact marks and scraping from the left rear corner of the trailer contacting the roadway during rollover. The impact marks and scraping were approximately 17.3 to 23.9 feet ending at final rest. Mr. Glover's slide to stop utilized published deceleration data of approximately 0.5 to 0.6 g. Mr. Glover would have been travelling approximately 16 to 21 mph at the time the left rear corner of the trailer contacted the roadway. The slide to stop speed should be lower when compared to pre-rollover speed. Mr. Glover's rollover threshold and speed utilize dimensions and geometry from the tractor-trailer, load, and roadway. The threshold values represent the lateral accelerations the tractor-trailer would have been capable of withstanding prior to a rollover event occurring. The static rollover threshold utilizes the tractor-trailers track width of approximately 72 inches and overall center of gravity (cg) of approximately 85 inches. The calculated static rollover threshold was approximately 0.42 g. The dynamic rollover threshold utilized the previous data in addition to the total lateral cg shift from body roll and load. The calculated dynamic rollover threshold was approximately 0.33 g with no lateral cg shift from the load. The corresponding dynamic rollover speed was approximately 24 to 28 mph. The calculated dynamic rollover threshold was approximately 0.26 g with an estimated 6 inches of lateral cg shift from the load. The corresponding dynamic rollover speed was approximately 22 to 25 mph. The speed at which rollover could occur is consistent with speed data from AT&T Fleet Complete and only requires a minimal lateral cg shift from the load of 6 inches. This is inconsistent with Mr. Glover's statement

that he normally travelled approximately 10 mph around that curve. This is inconsistent with Mr. Glover's statements that a tractor should be travelling 10-15 mph to take that curve safely. This is inconsistent with the witnesses' statements that Mr. Glover was travelling approximately 10 mph through the turn.

*Figure 8. Final rest position of Freightliner tractor-trailer.*
